# Manhole Inspection Summary

Manhole # S13O\_\_007MH

**Location** Address: **2816 S Dukland ST**

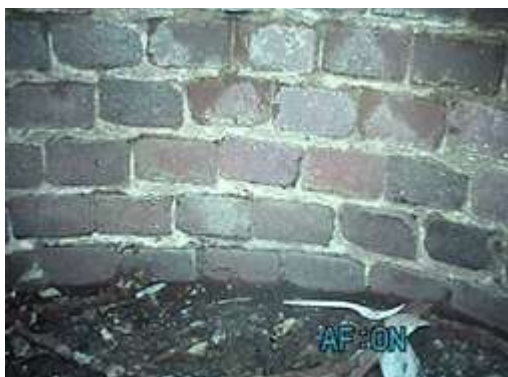
Defect 1

debris on bench

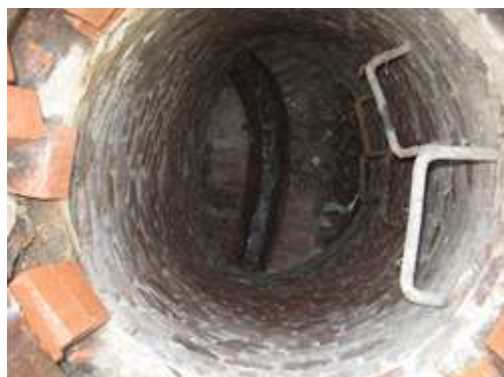
Defect 3

**Steps** Count: **5** Missing: **0** ☒ **Corroded**

corroded steps

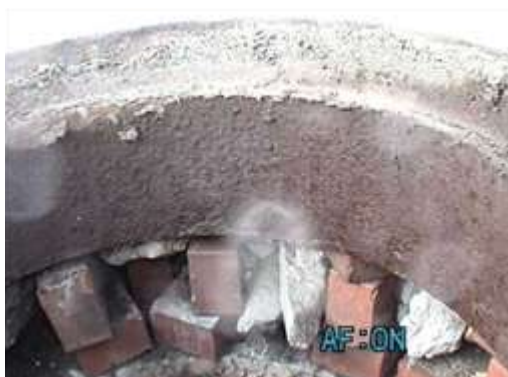
Defect 2

Condition: ☐ Sound ☐ Cracked ☐ Root Intrusion ☒ **Loose Brick** ☒ **Deteriorated**

loose bricks/ deteriorated chimney

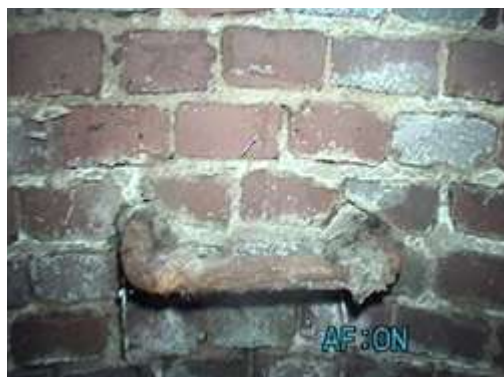
**Surcharge** ☒ **Evidence Of Surcharge** Depth: **3** (ft.) ☐ Active Surcharge Present

signs of surcharge and corroded steps

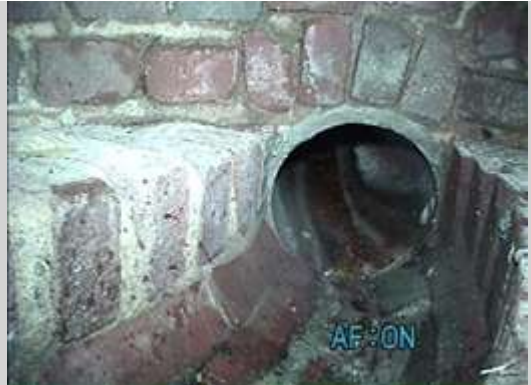
12 O'Clock Outflow

8 in. Circular Gravity Sewer  
Pipe Out @ 12 O'Clock

Pipe Height: **8.4** (in.) Rod and Bar (Angled)  
Pipe Material: **Clay** ☐ Pipe Lined  
Invert Depth: **10.48** (ft.) Flow Characteristics: **Slow**  
Deposits: ☒ None ☐ Mud ☐ Sludge ☐ Debris ☐ Grease  
Silt Depth: **0** (in.) Deposits Extent:  
Infiltration: **None** Pipe Seal Cond: **Sound**

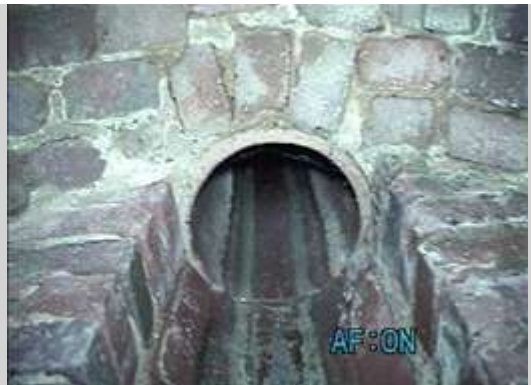
8 O'Clock Inflow

8 in. Circular Gravity Sewer  
Pipe In @ 8 O'Clock

Pipe Height: **8.4** (in.) Rod and Bar (Angled)  
Pipe Material: **Clay** ☐ Pipe Lined  
Invert Depth: **10.50** (ft.) Flow Characteristics: **None**  
Deposits: ☒ None ☐ Mud ☐ Sludge ☐ Debris ☐ Grease  
Silt Depth: **0** (in.) Deposits Extent:  
Infiltration: **None** Pipe Seal Cond: **Sound**
